# Manhole Inspection Summary

Manhole # S31S\_\_004MH

**Location** Address: **w ostend st**

Cross Street: **howard st**

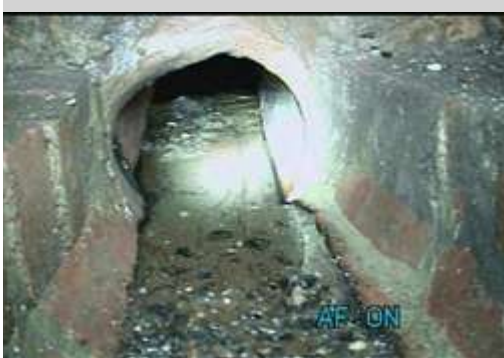
misc

channel deris

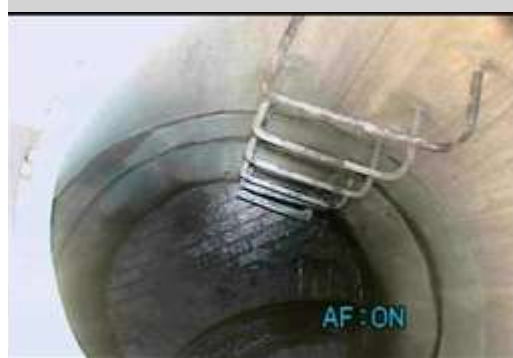
Defect 1

**Steps** Count: **6** Missing: **0** ☒ **Corroded**

steps

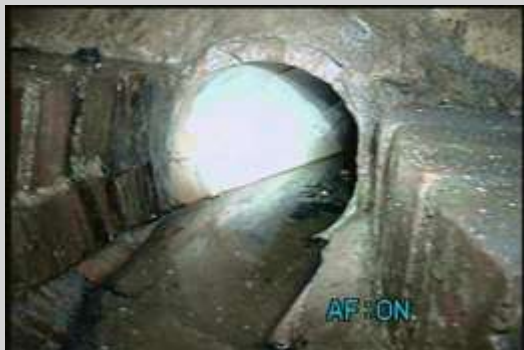
12 O'Clock Outflow

8 in. Circular Gravity Sewer  
Pipe Out @ 12 O'Clock

Pipe Height: 0 (in.) Direct

Pipe Material: Clay ☐ Pipe Lined

Invert Depth: 8.70 (ft.) Flow Characteristics: None

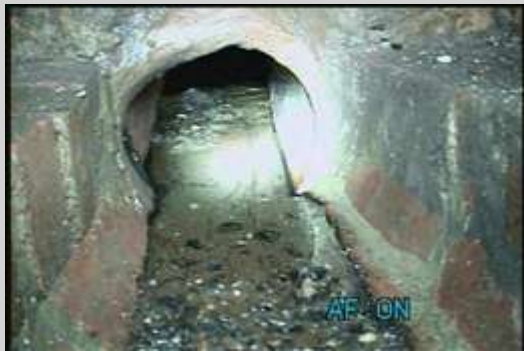
5 O'Clock Inflow

8 in. Circular Gravity Sewer  
Pipe In @ 5 O'Clock

Pipe Height: 0 (in.) Direct

Pipe Material: Clay ☐ Pipe Lined

Invert Depth: 8.40 (ft.) Flow Characteristics: None

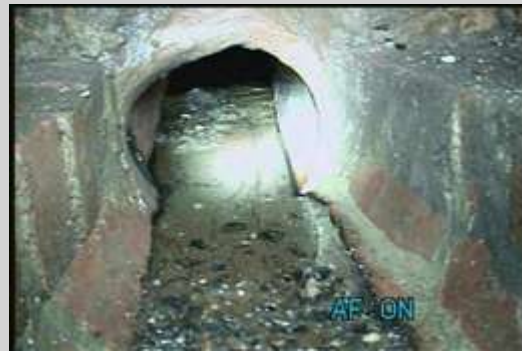
misc

channel deris
